PARASURE

Synthetic Cleaning Efficacy Indicators

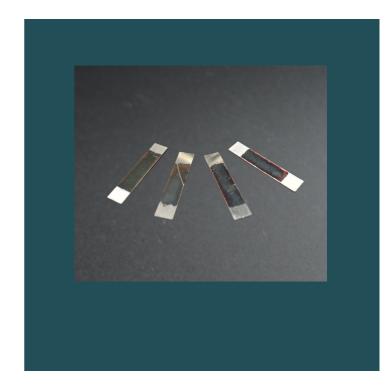
The ParaSure Synthetic Cleaning Efficacy Indicators offer a unique and cost-effective option for all healthcare facilities to ensure the decontamination process and soil removal efficacy is in accordance with EN ISO 15883 1-2-5. The indicators are designed to be used in conjunction with the ParaSure Standard Metal Basket (PS1610).

This system provides a cost-effective way of ensuring the washer-disinfector is functioning correctly by removing all soil from the indicator. The diagnostic technology gives a clear and instant result when used with the comprehensive reference guide (see overleaf).
